CURRENT CONDITIONS REPORT FOR THE SAGINAW RIVER, FLOODPLAIN, AND BAY

Prepared for
THE DOW CHEMICAL COMPANY

14 September 2007

Photographic Log of Saginaw River

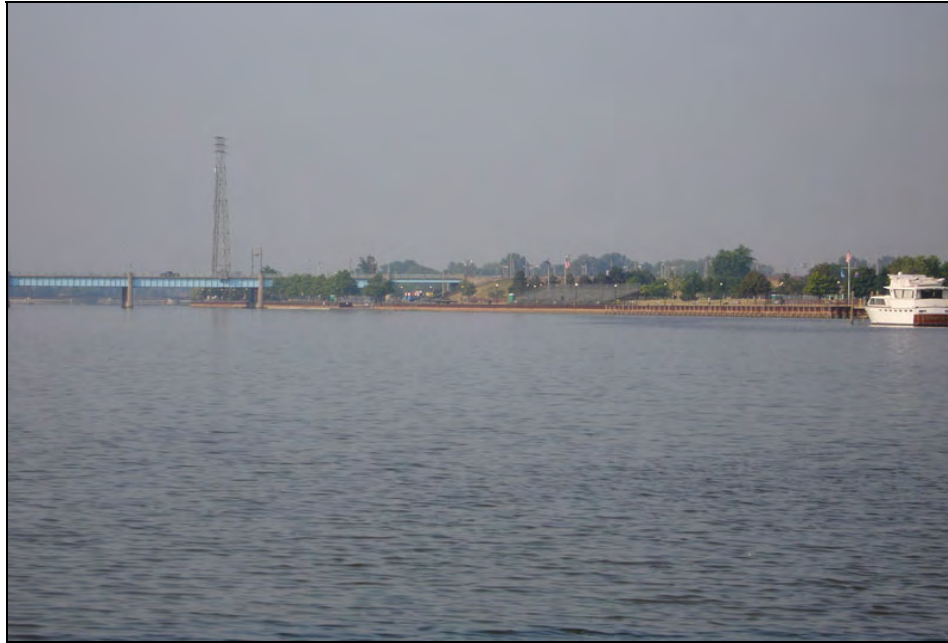
Photo 1: Armored river bank in Bay City, MI

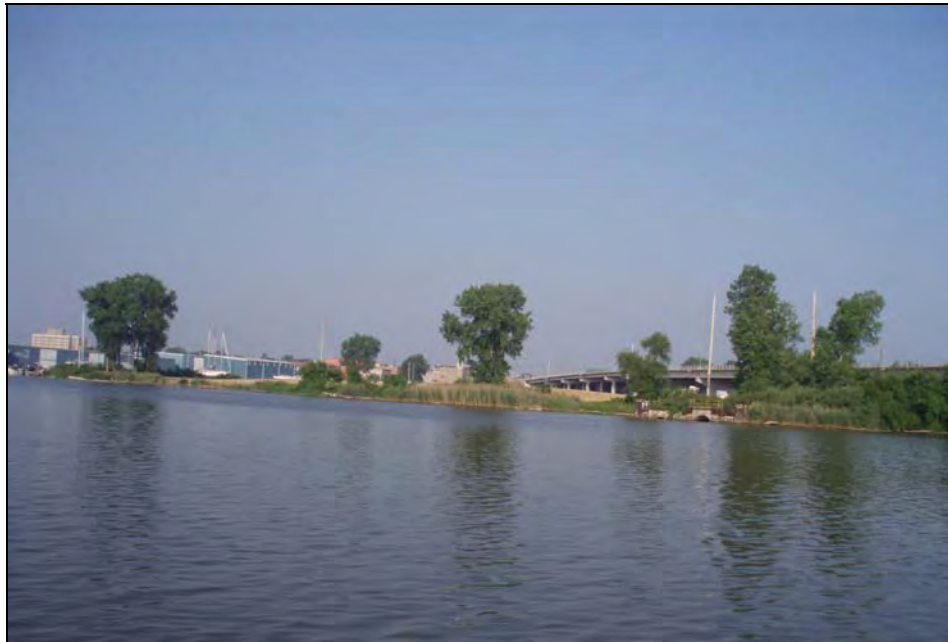
Photo 2: Wastewater treatment plant outfall near Bay City, MI

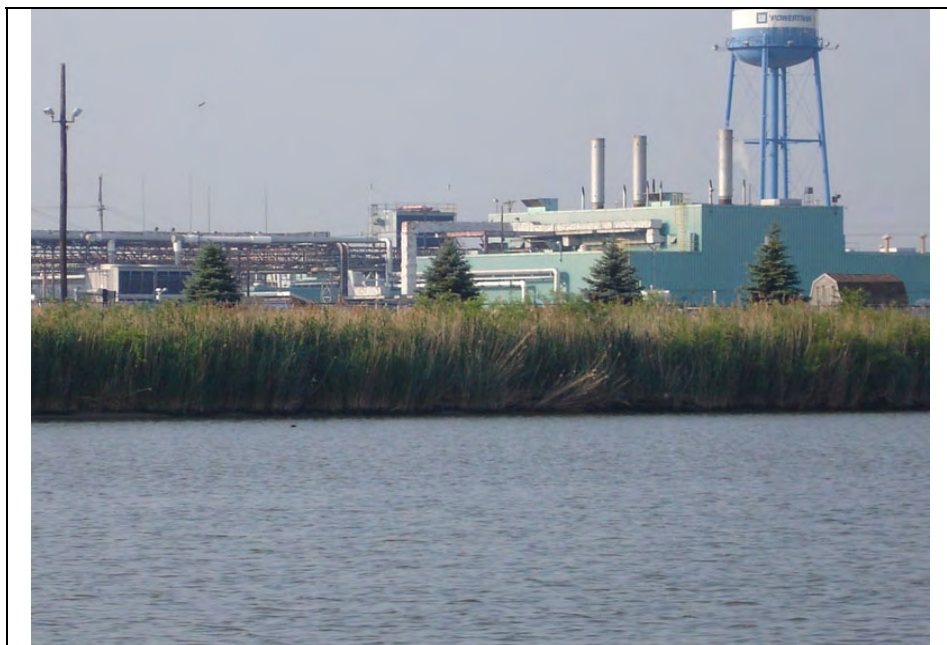
Photo 3: Riparian vegetation along Saginaw River in Bay City, MI

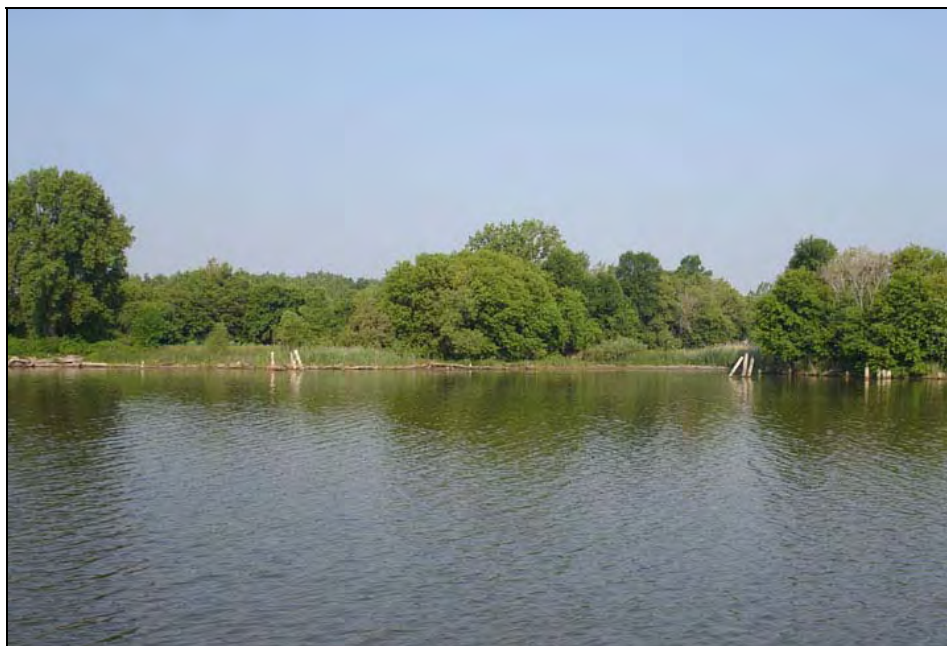
Photo 4: Middleground Island, Bay City, MI

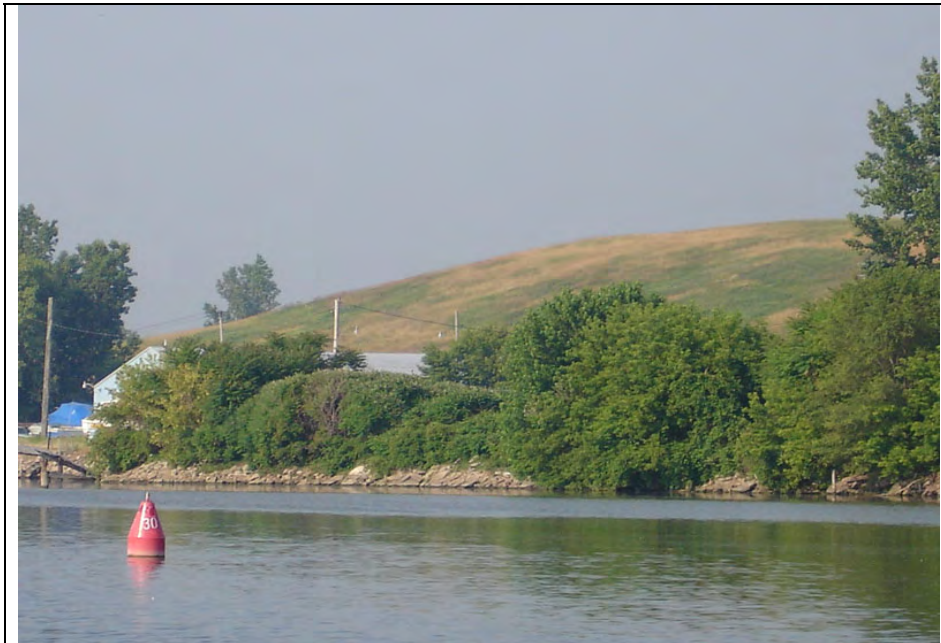
Photo 5: Landfill near Bay City, MI

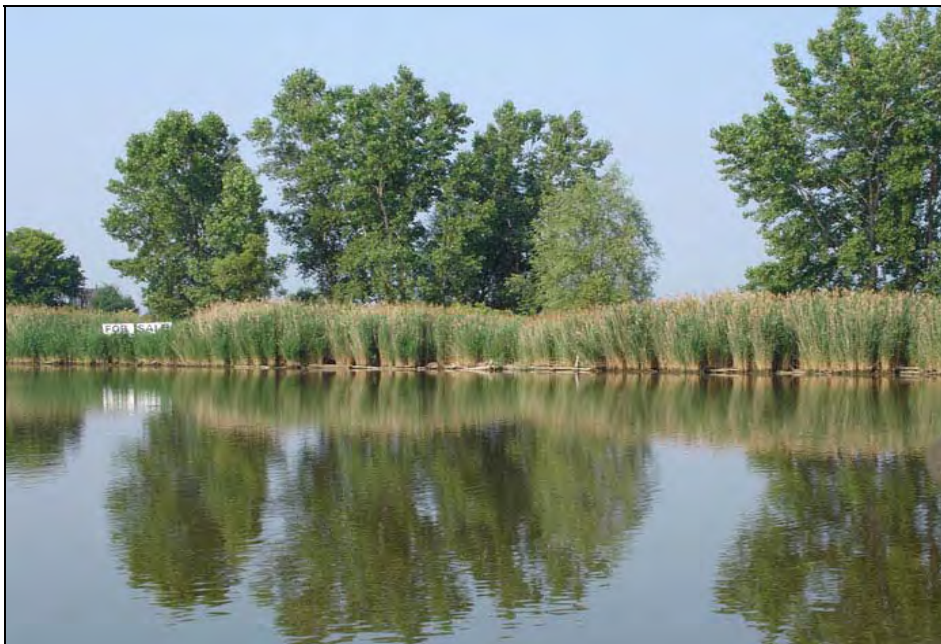
Photo 6: Riparian vegetation between Bay City and Saginaw, MI

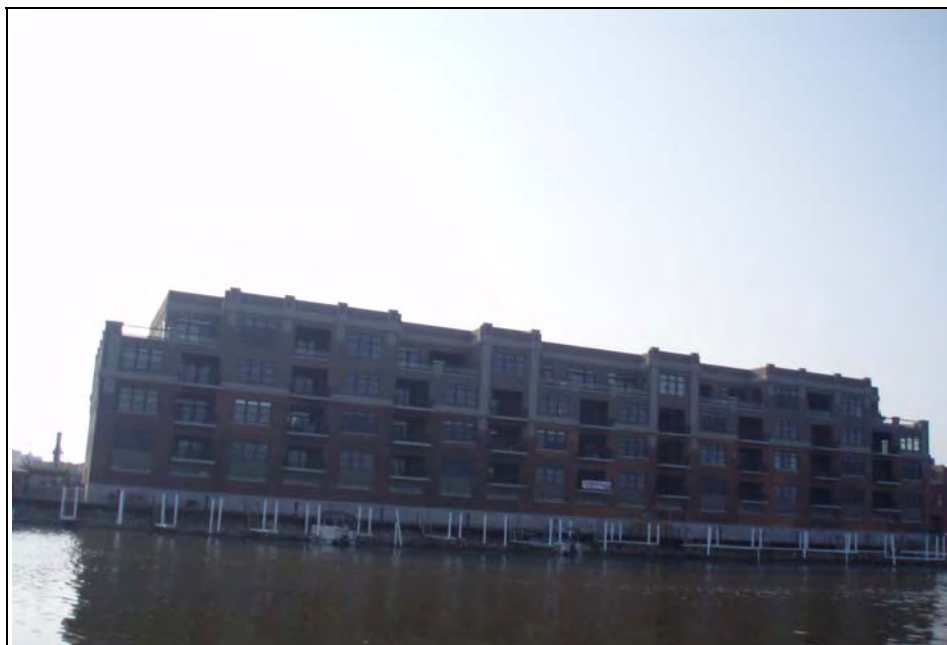
Photo 7: Residential development near Saginaw, MI

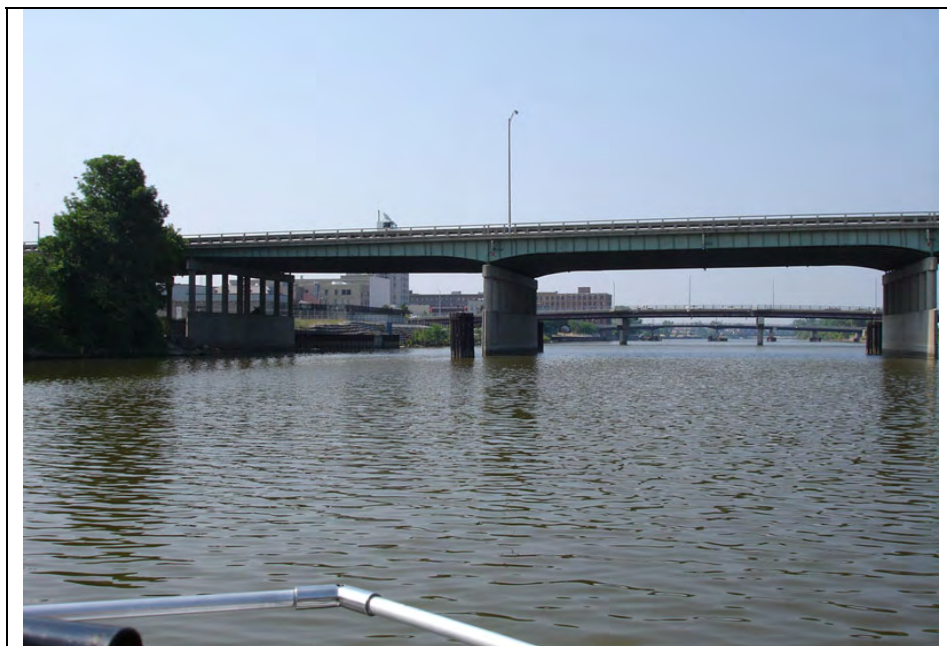
Photo 8: Bridges in Saginaw, MI

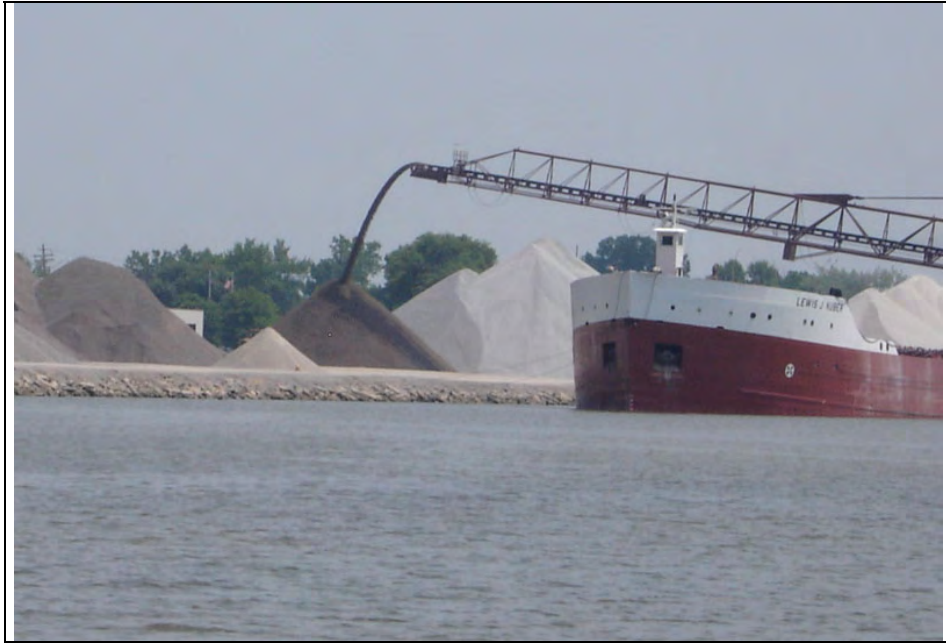
Photo 9: Gravel yards adjacent to the Saginaw River, near Saginaw, MI

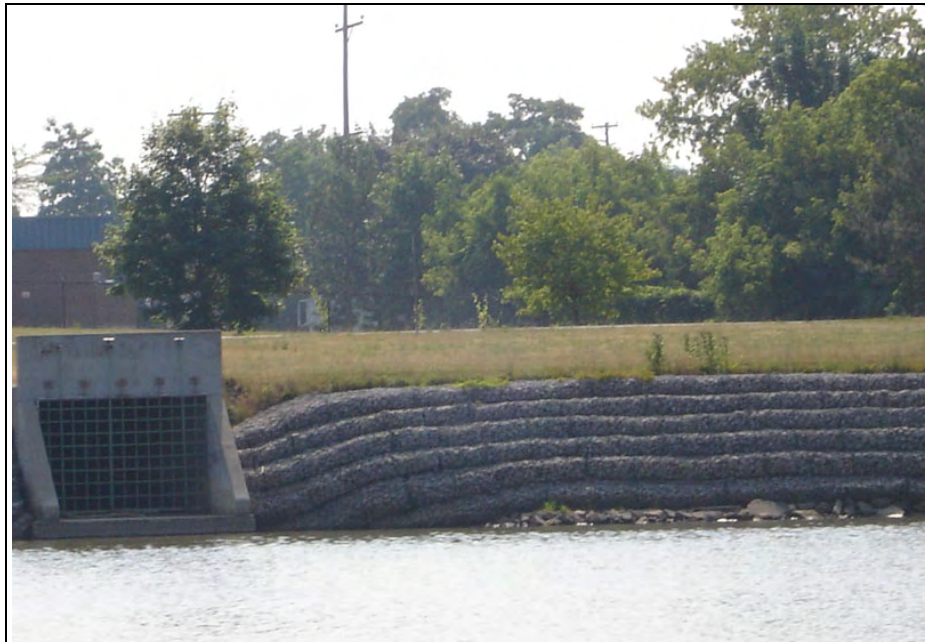
Photo 10: Armored bank and outfall in Saginaw, MI

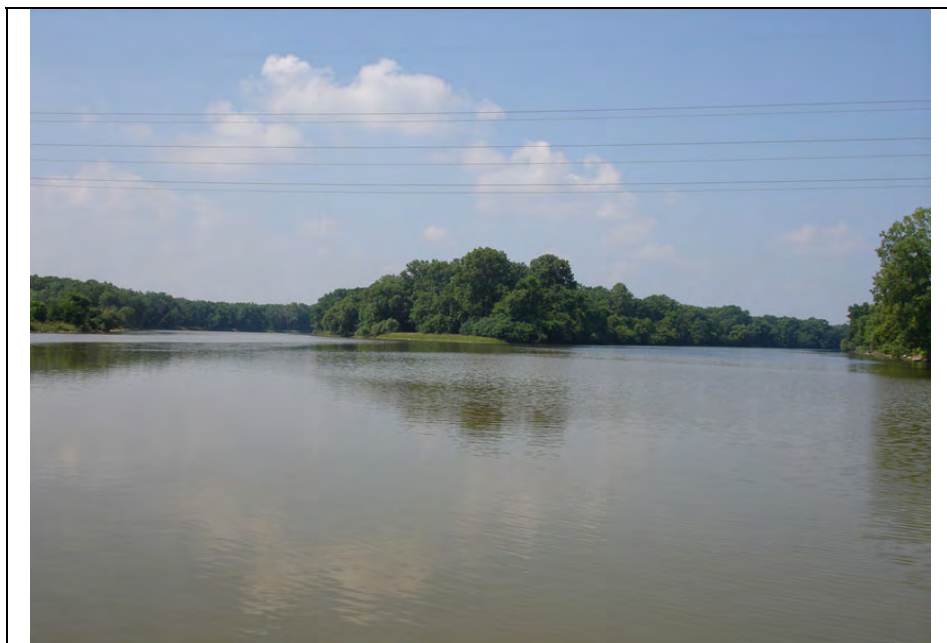
Photo 11: The confluence of the Shiawassee (left) and Tittabawassee (right) Rivers forming the Saginaw River near Saginaw MI
